Manhole Inspection Summary

Manhole # S41I__052MH

Insp Date: **5/14/08 9:36 AM**

Location Address: **side of 1400 eastern ave**

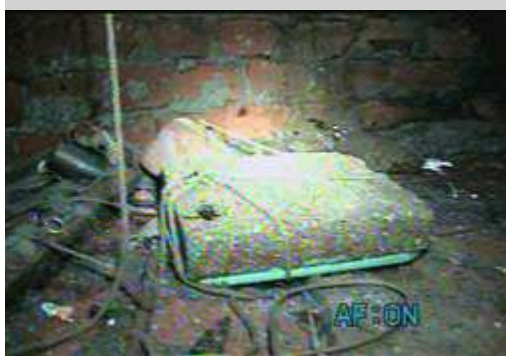
Defect 4

Condition: ☐ Sound ☐ Cracked ☐ Root Intrusion ☐ Deteriorated ☐ Leaks ☒ **Debris**

Bench debris

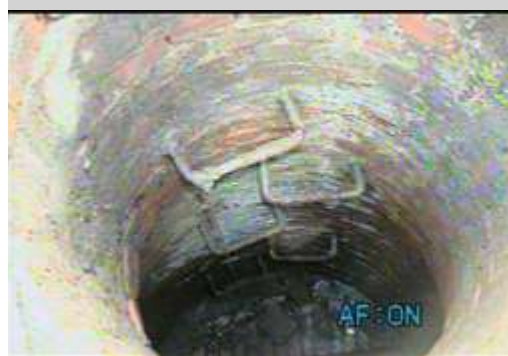
Defect 3

Infiltration: ☐ None ☐ Joint ☐ Cracks ☐ Mortar ☐ Roots ☒ **Wall**

Count: **5** Missing: **0** ☒ **Corroded**

corroded steps, barrel infiltration

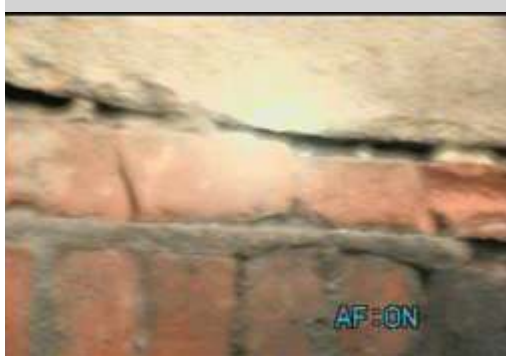
Defect 2

Condition: ☐ Sound ☐ Cracked ☐ Root Intrusion ☒ **Loose Brick** ☐ Deteriorated

adj

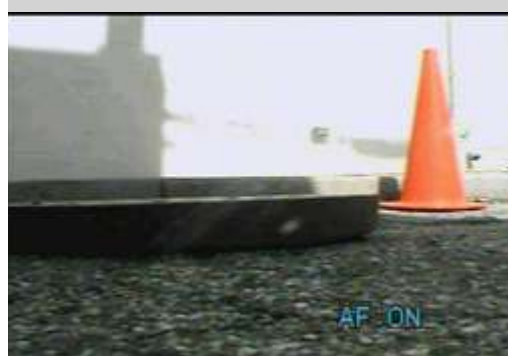
Defect 1

Condition: **Cracked**

crack cover
